**DOT/FAA/AR-96/21**

# **Composite Failure Analysis Handbook Update 1**

**WL-TR-93-4004**

August 1997

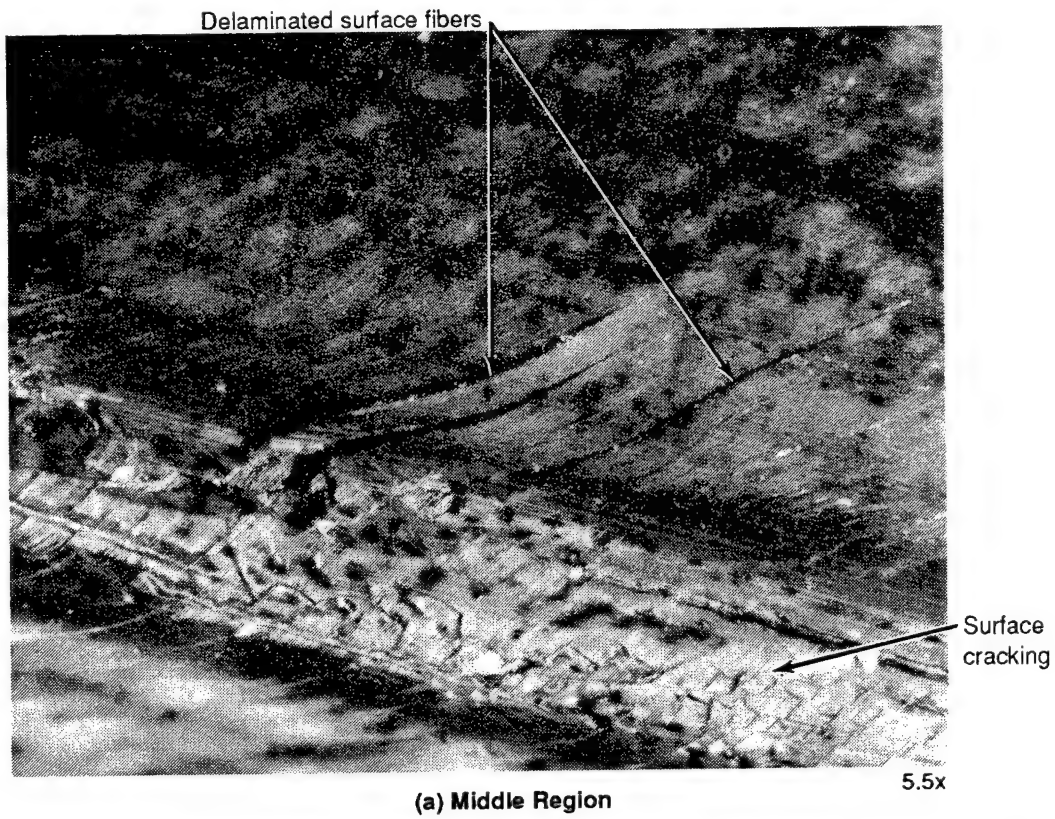
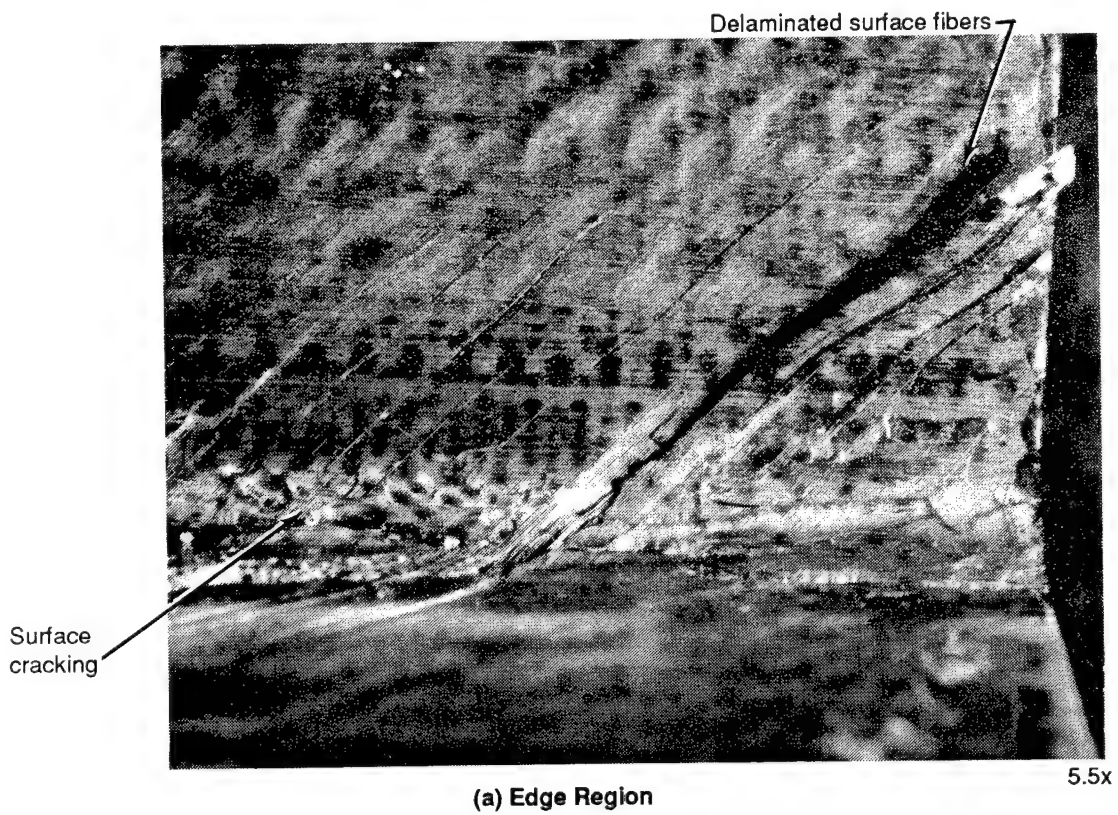
Surface fibers within the inner radius of the "knee" were cracked (fig. 4). Deformations, such as rippling and buckling, were also present along the entire length of the inner radius of the knee. Small indentations and elongated depressions or "tracks" were present along the inner knee surface (fig. 5). The surface of the depressions was shiny indicating that the depressions probably occurred during the fabrication process. Some of the "tracks" contained cracks which went through the surface ply. There were no surface defects or anomalies on the outside surface of the component. Strain gages were located on both sides of one of the flanges.

Figure 4. Micrographs Showing Regions of Surface Fibers Delamination and Cracking Along the Middle and Edges of the Inner Radius

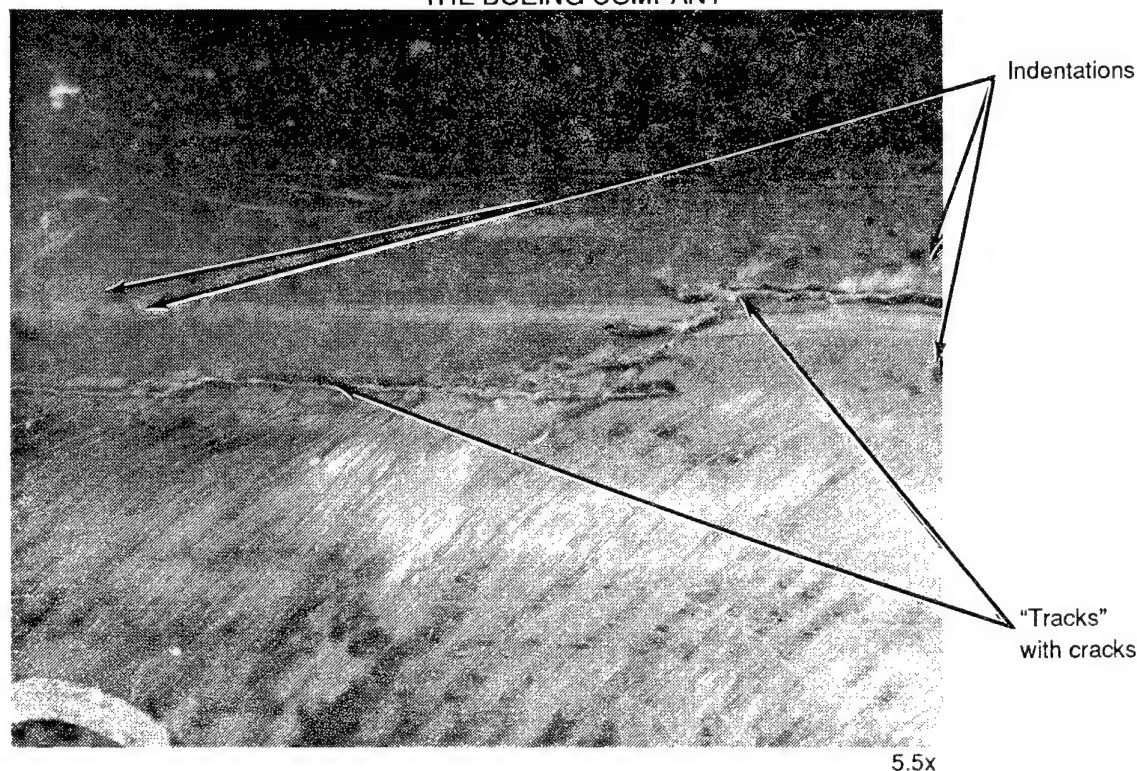
Figure 5. Micrograph of the Indentations and "Tracks" Along the Inner Radius

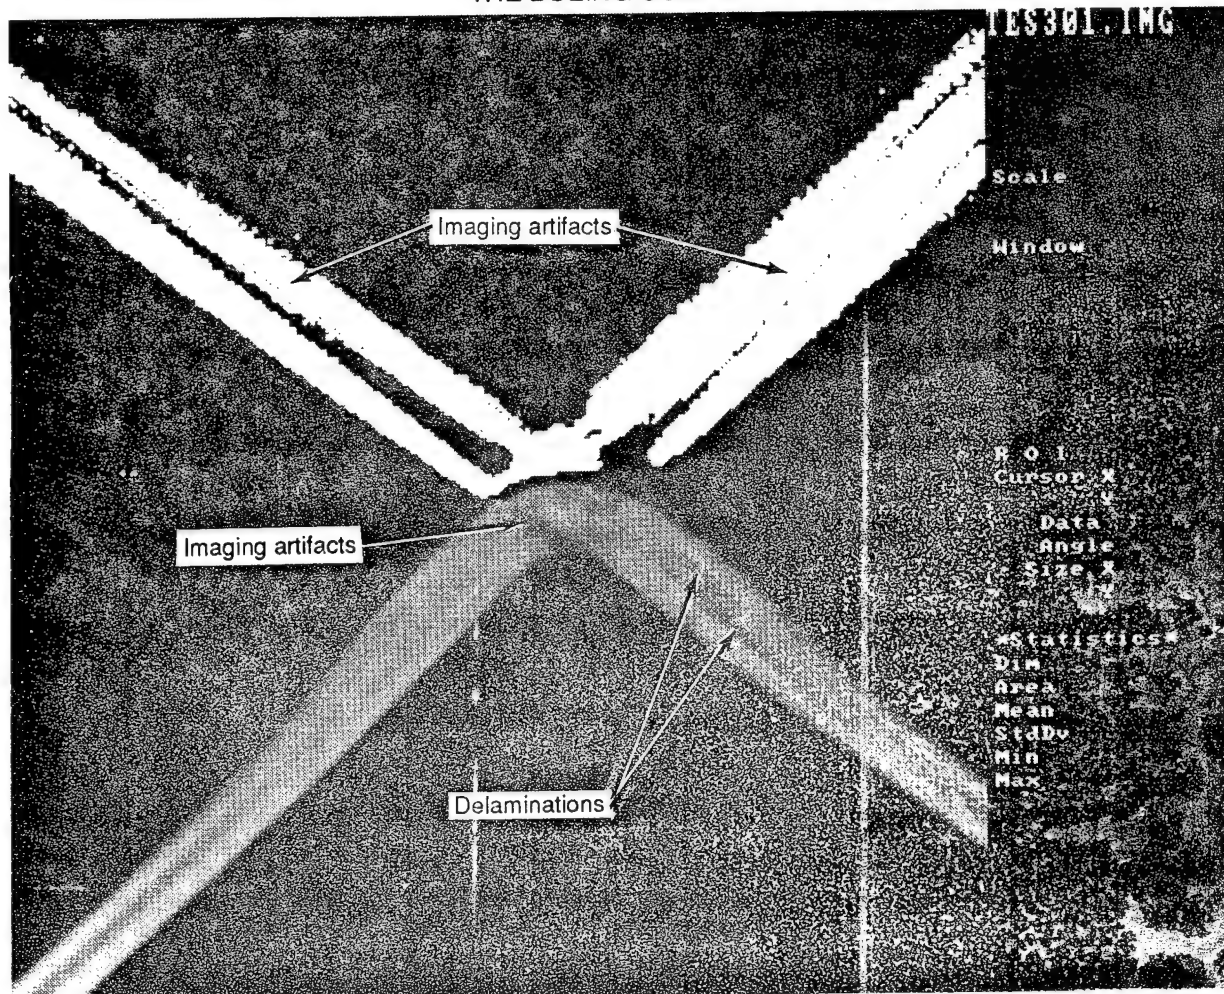
The part was subsequently dried in an oven at 90°F for 30 minutes before another set of scans was performed. This time the edges were sealed, the surface of the part was sprayed with a lacquer, and the fastener holes were plugged (fig 9). The part was then rescanned which revealed that it was almost completely delaminated (fig. 10). The grip areas were not delaminated as observed in the pulse-echo analysis.

Figure 6. CT Image Showing the Imaging Artifacts and Some of the Actual Delaminations

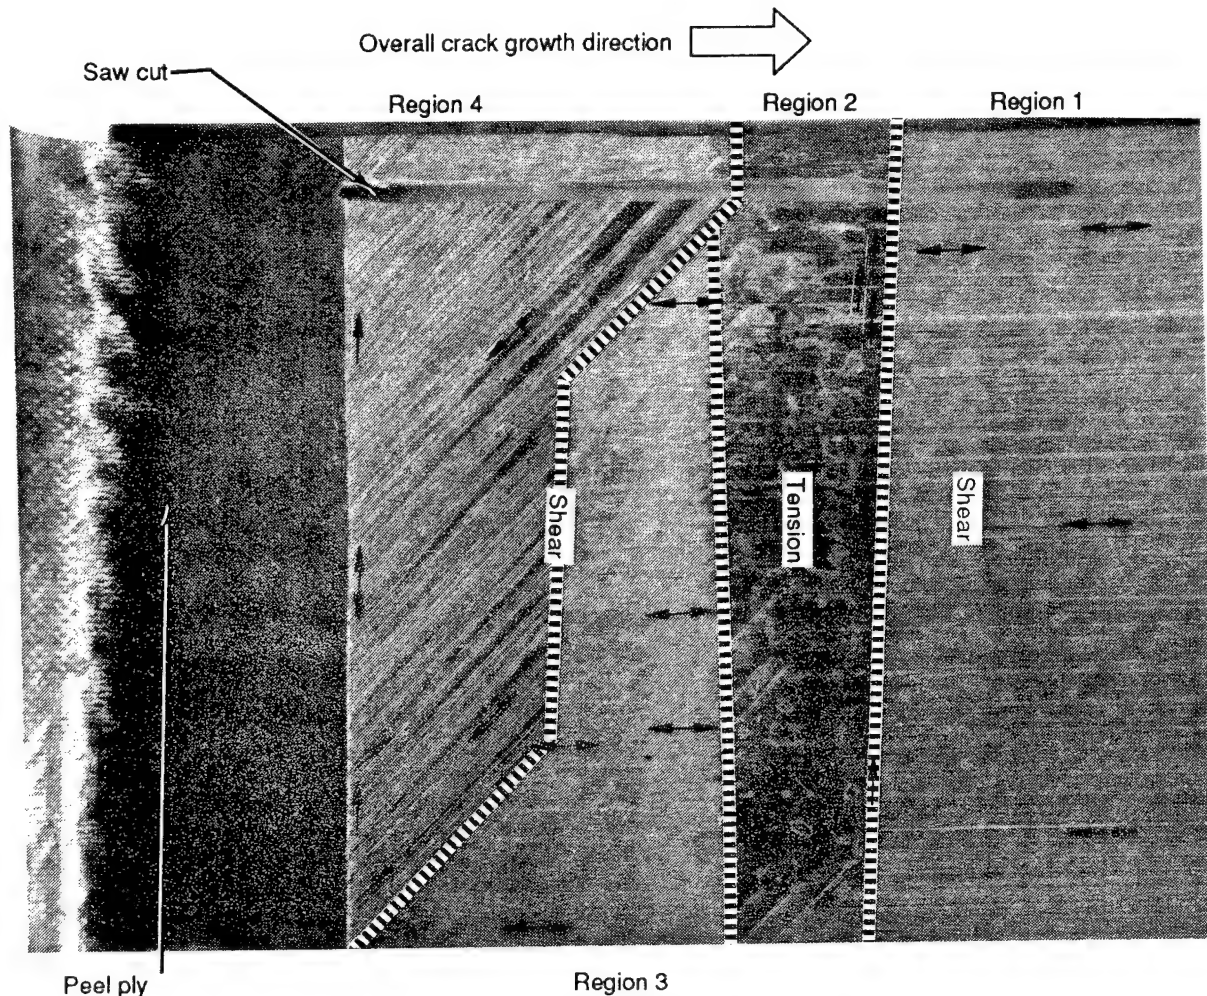
Initially, the component was gripped at the edges of the flanges using the fastener holes. As loading began, one edge was pulled away from the other edge which induced an initial shear loading condition inside the component at the edge of the peel ply. The presence of the peel ply in the center (where the maximum shear stress occurred) provided a high stress concentration region which allowed the cracks to initiate. As the edges were pulled further apart, the cracks continued to propagate by shear.

Note: Four regions are identified, exhibiting two different fracture modes:

- Region 1: Mode II (shear)
- Region 2: Mode I (tension)
- Region 3: Mode II (shear) 0-degree fibers
- Region 4: Mode II (shear) 45-degree fibers

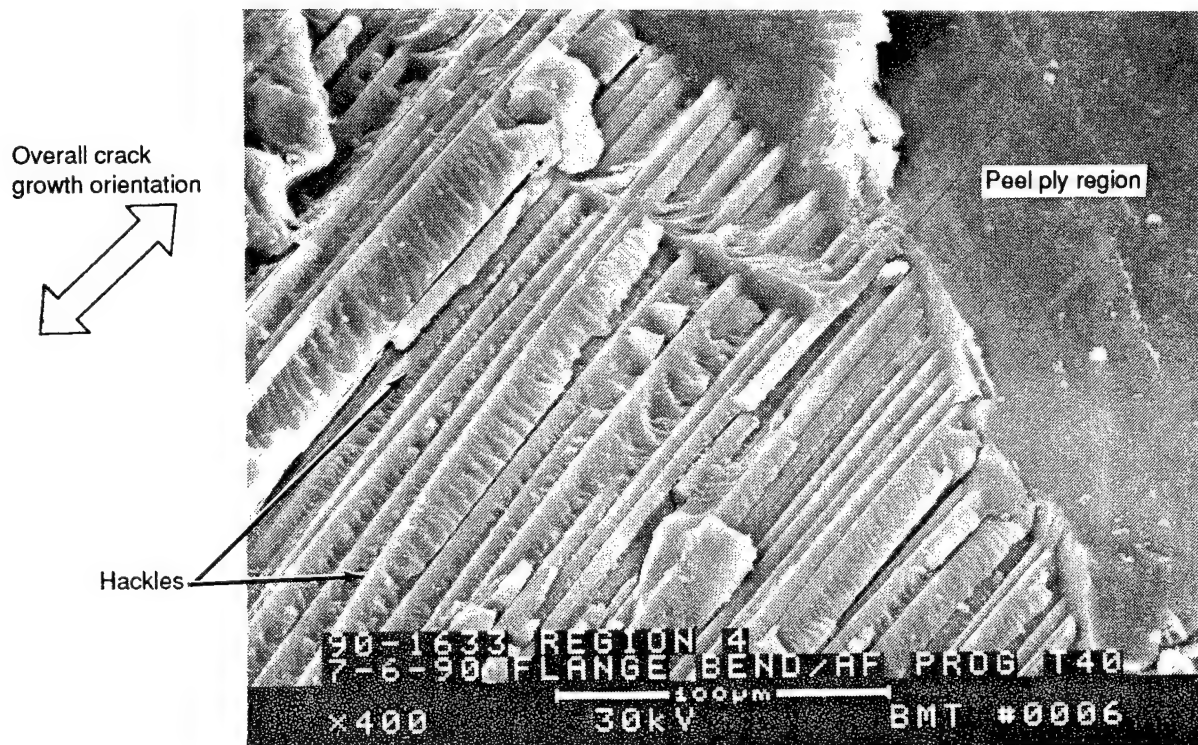
For the one flange, the crack propagated entirely by shear. However, the cracking on the other flange changed modes because the stress orientation had altered significantly enough, due to the component's deformation, to continue the shearing mechanism. As a result, localized buckling occurred which caused a change in the propagation mode from shear to tensile. After further displacement, deformation of the part again changed the loading orientation which changed the propagation mode back to the more energetically favorable shearing mode. Also, the stresses were now sufficient at this point to cause additional delaminations to initiate and propagate in the knee region. This continued until the crack reached the gripped region which was clamped and restricted further crack propagation.

Figure 14. SEM Micrograph of a Mode II-Type (Shear) Fracture Surface in Region 4 Adjacent to the Peel Ply

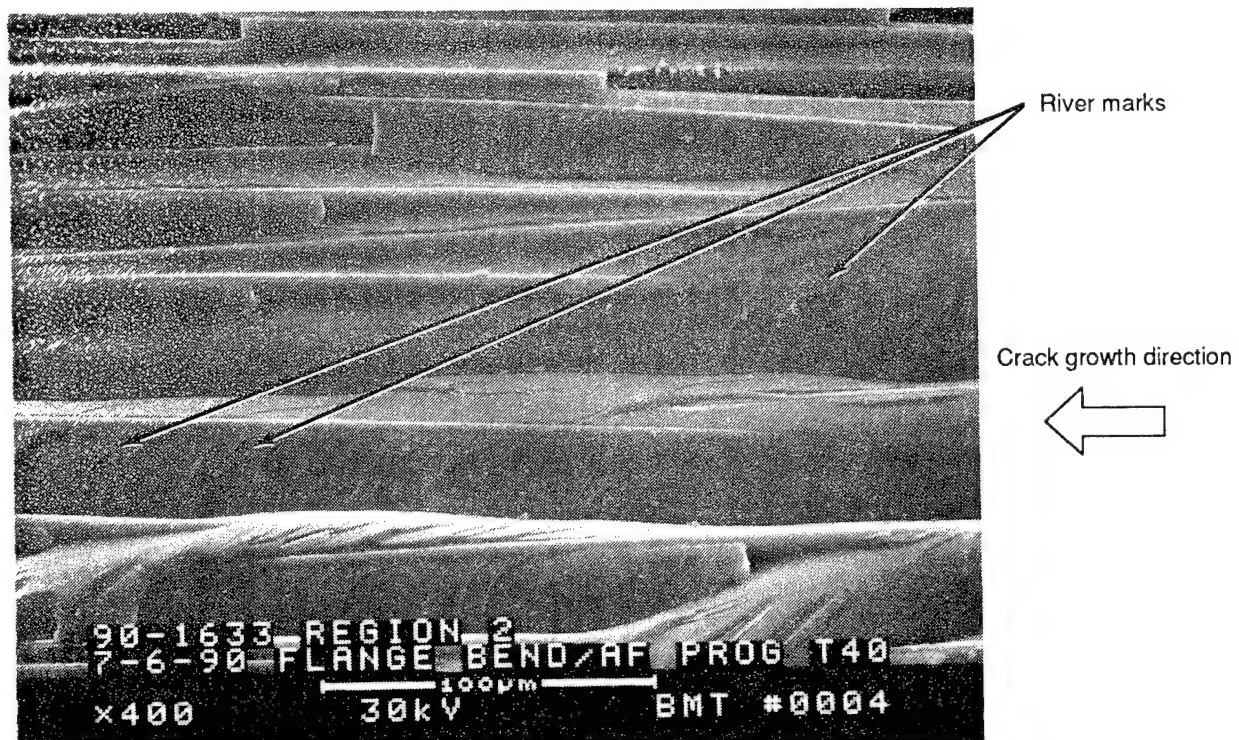
Figure 15. SEM Micrograph of a Mode I-Type (Tension) Fracture Surface in Region 2

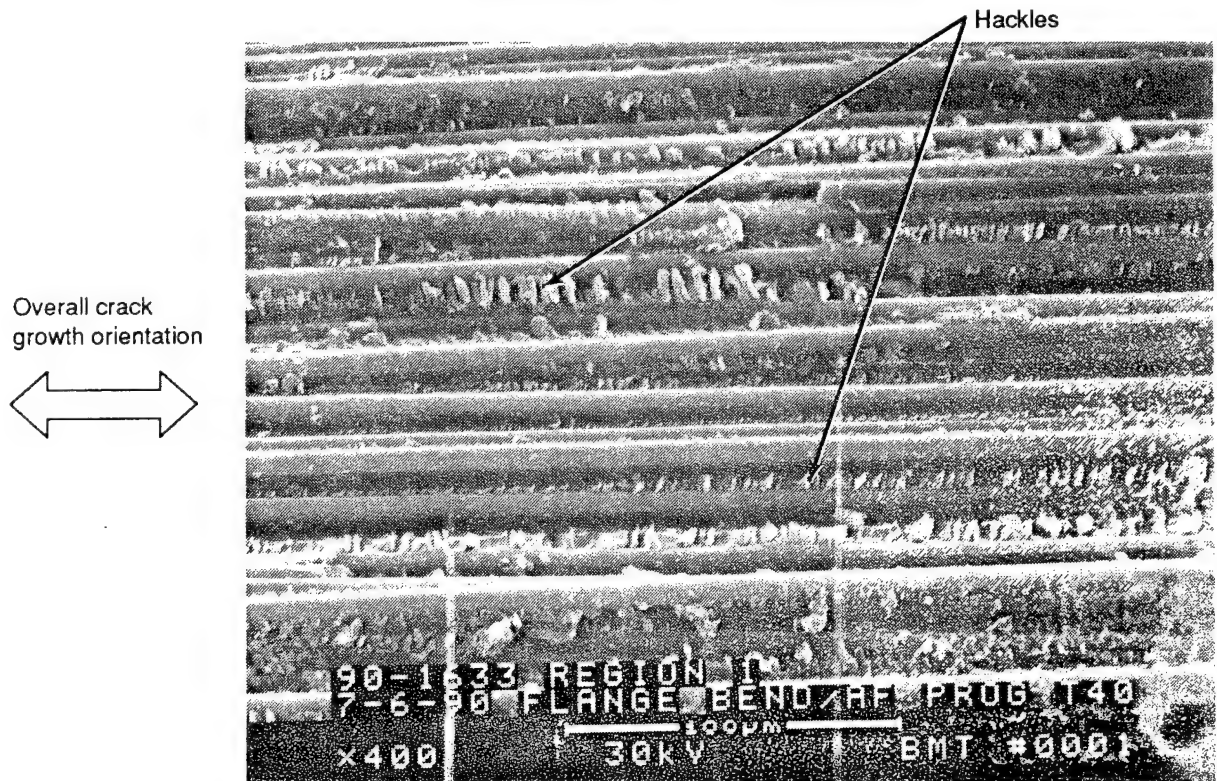
Figure 16. SEM Micrograph of a Mode II-Type (Shear) Fracture Surface in Region 1

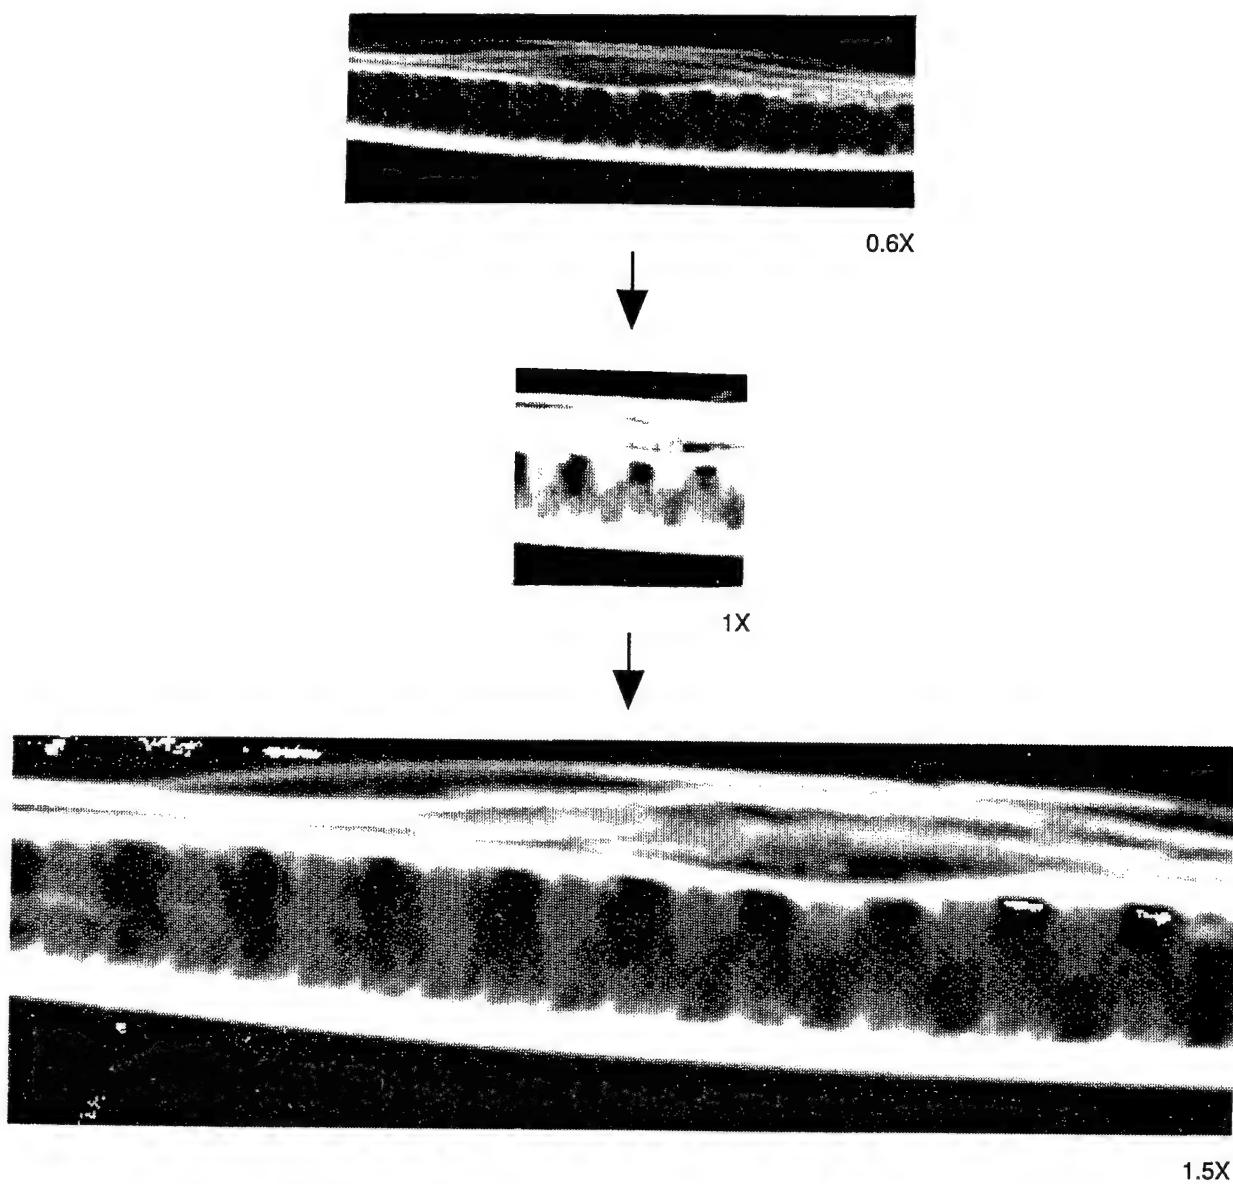
Figures 8 through 11 through show the various images of the slices through the component. The longitudinal slices 1, 2, & 3 show the damage present in the honeycomb regions in the center of the component. The front half of the panel appears to have been crushed by a macroscopic shearing of the upper front half of the facesheet. The back half exhibited little if no damage. However near the bulge, the core appeared to be crushed in the short transverse direction. There was no evidence showing any longitudinal buckling trends to either end (from one end to the other). This transverse damage was located all along the back half of the component.

*Figure 8. CT Images of the Transverse Scan Through the Delaminated Zone*

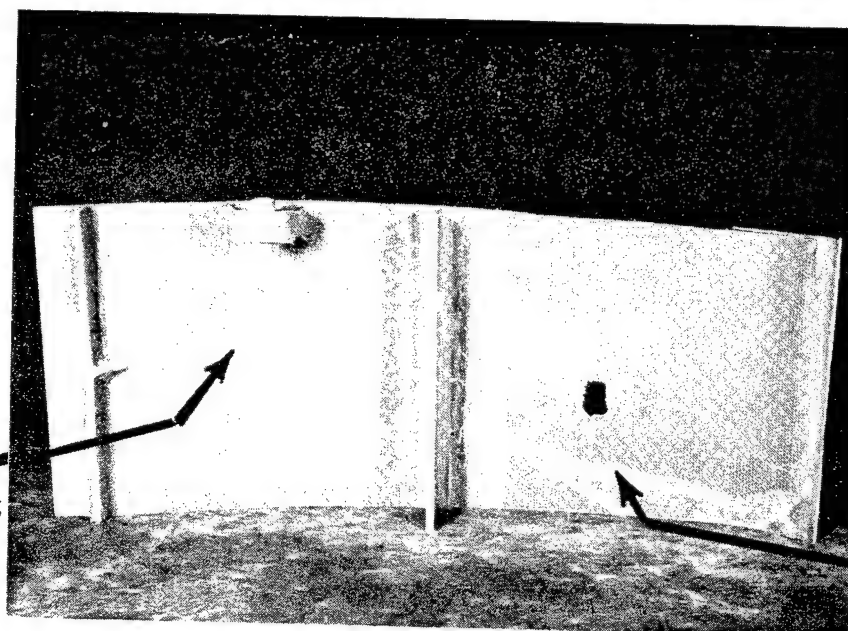
large delaminated  
region corresponding  
to a sanded region  
on the outer surface

*Figure 3. Photograph of the Inner Surface of the Upper Wing Surface*

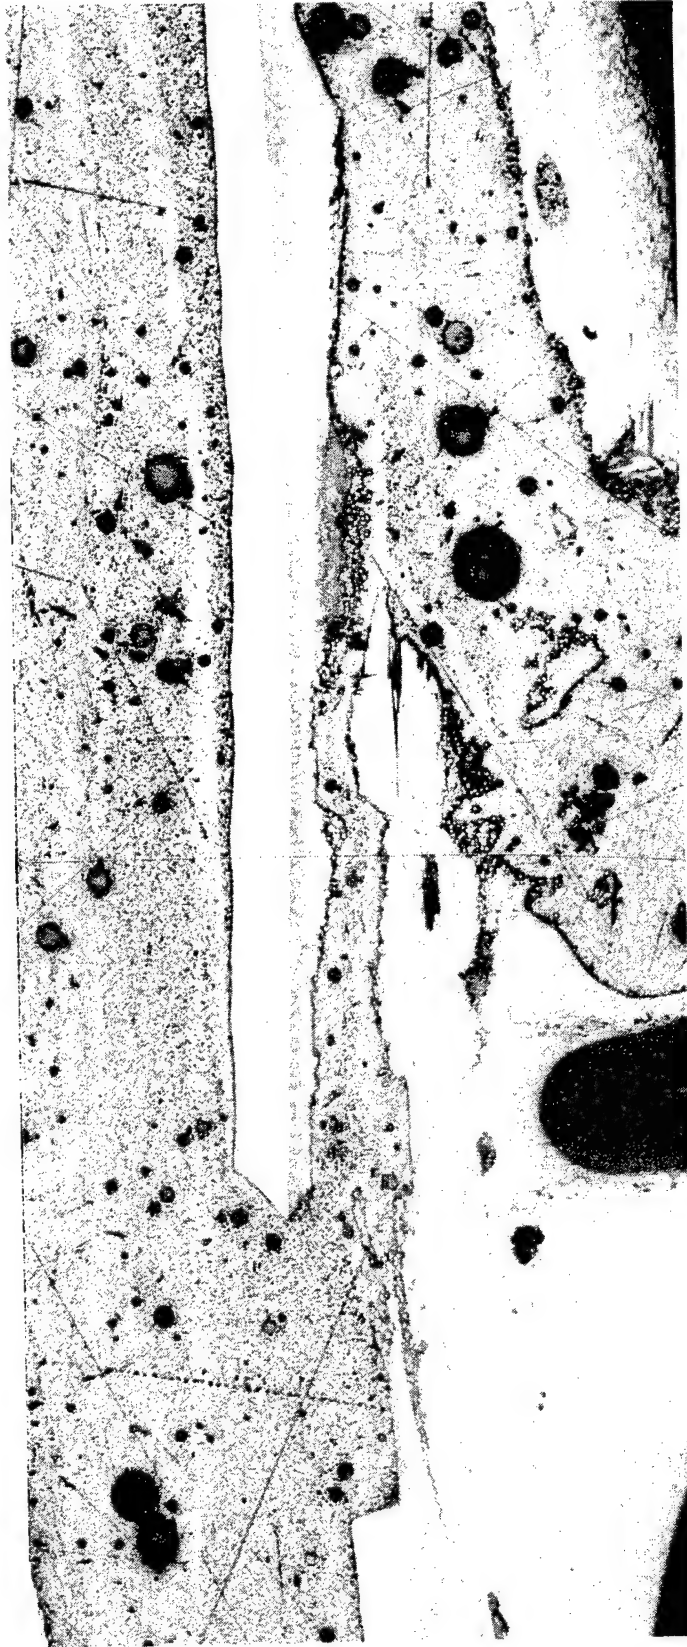
Figure 10. Cross Section through a Crack in the Upper Wing Skin

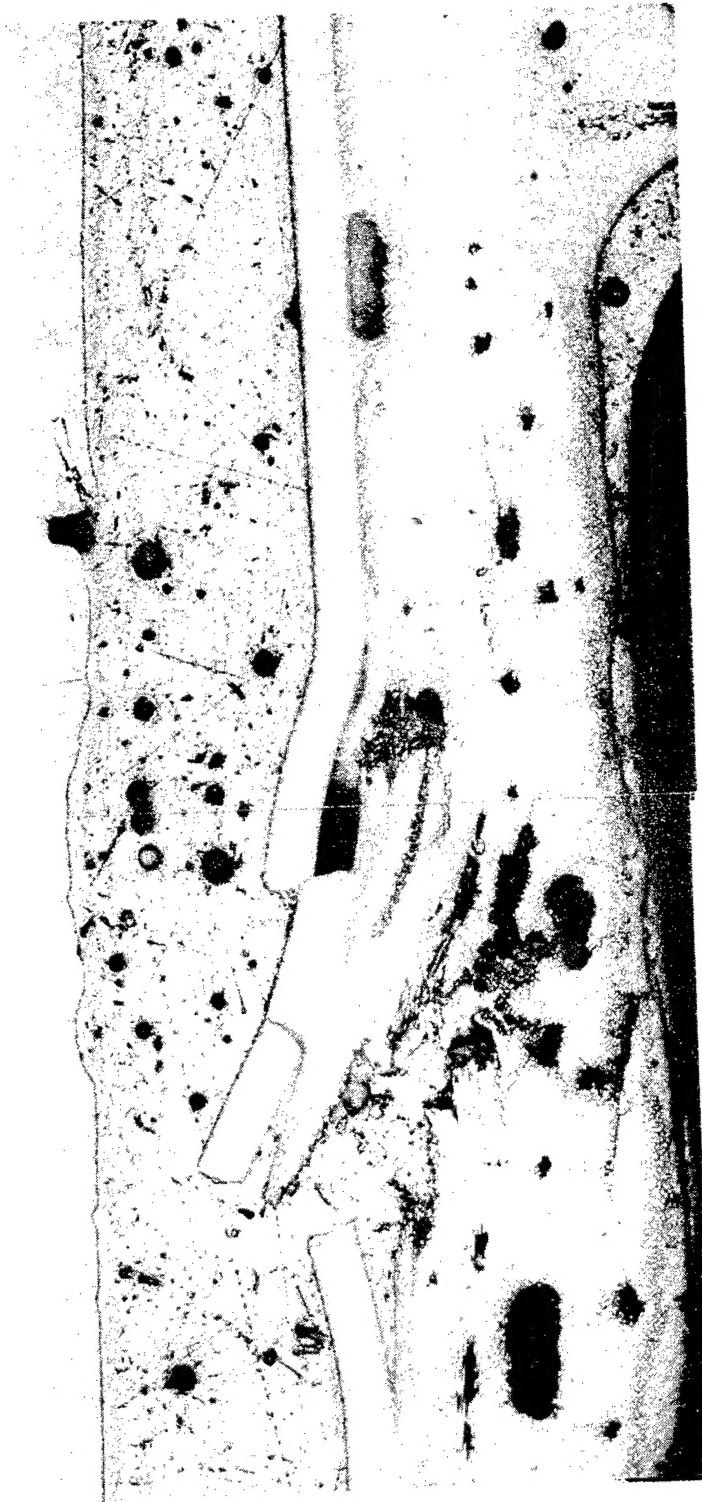
Figure 11. Cross Section through a Crack in the Upper Wing Skin

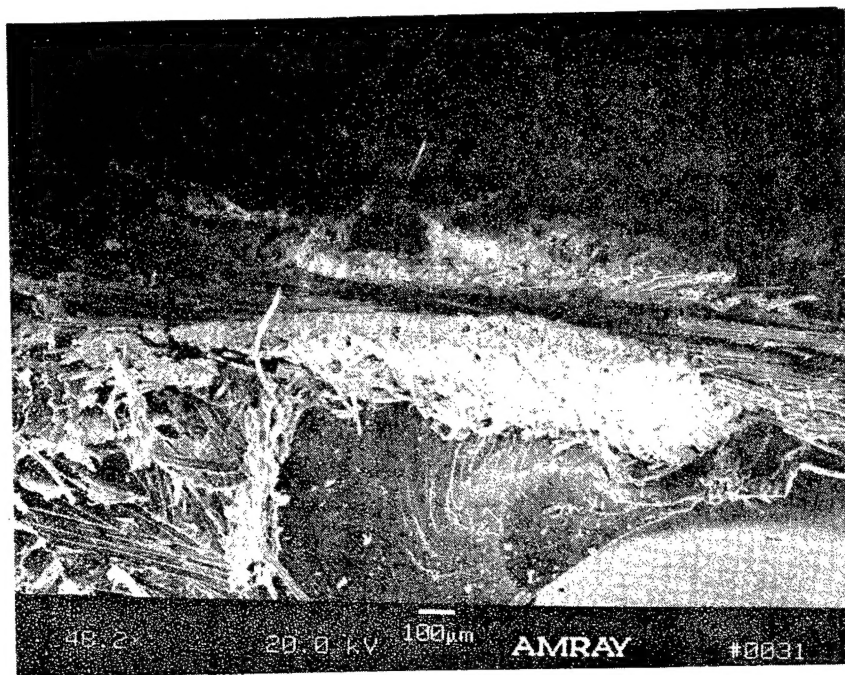
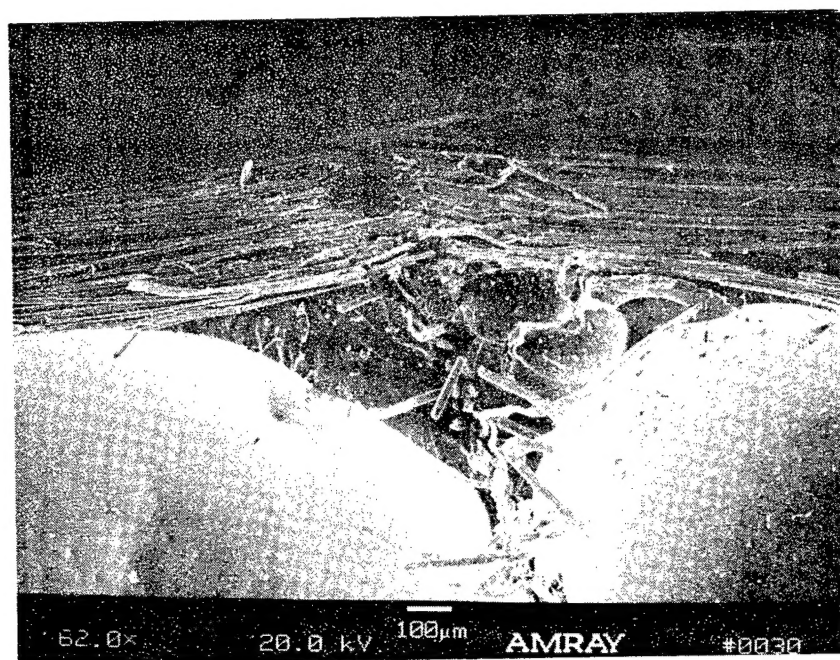
Figure 12. SEM Photographs of the Crack Surfaces

1. The wing section contained two major cracks which extended from the leading edge of the wing to the aft edge. Another small crack was located at the edge, in the middle of the wing section. All of the cracks were on the upper wing skin.
2. Chemical analysis of the materials did not reveal any anomalies in the materials. No material or fabrication anomalies which could have contributed to crack initiation were found.
3. Cross-sectional and SEM analysis revealed the fractures were caused by buckling of the upper skin. The specific cause of the bucking could not be determined.

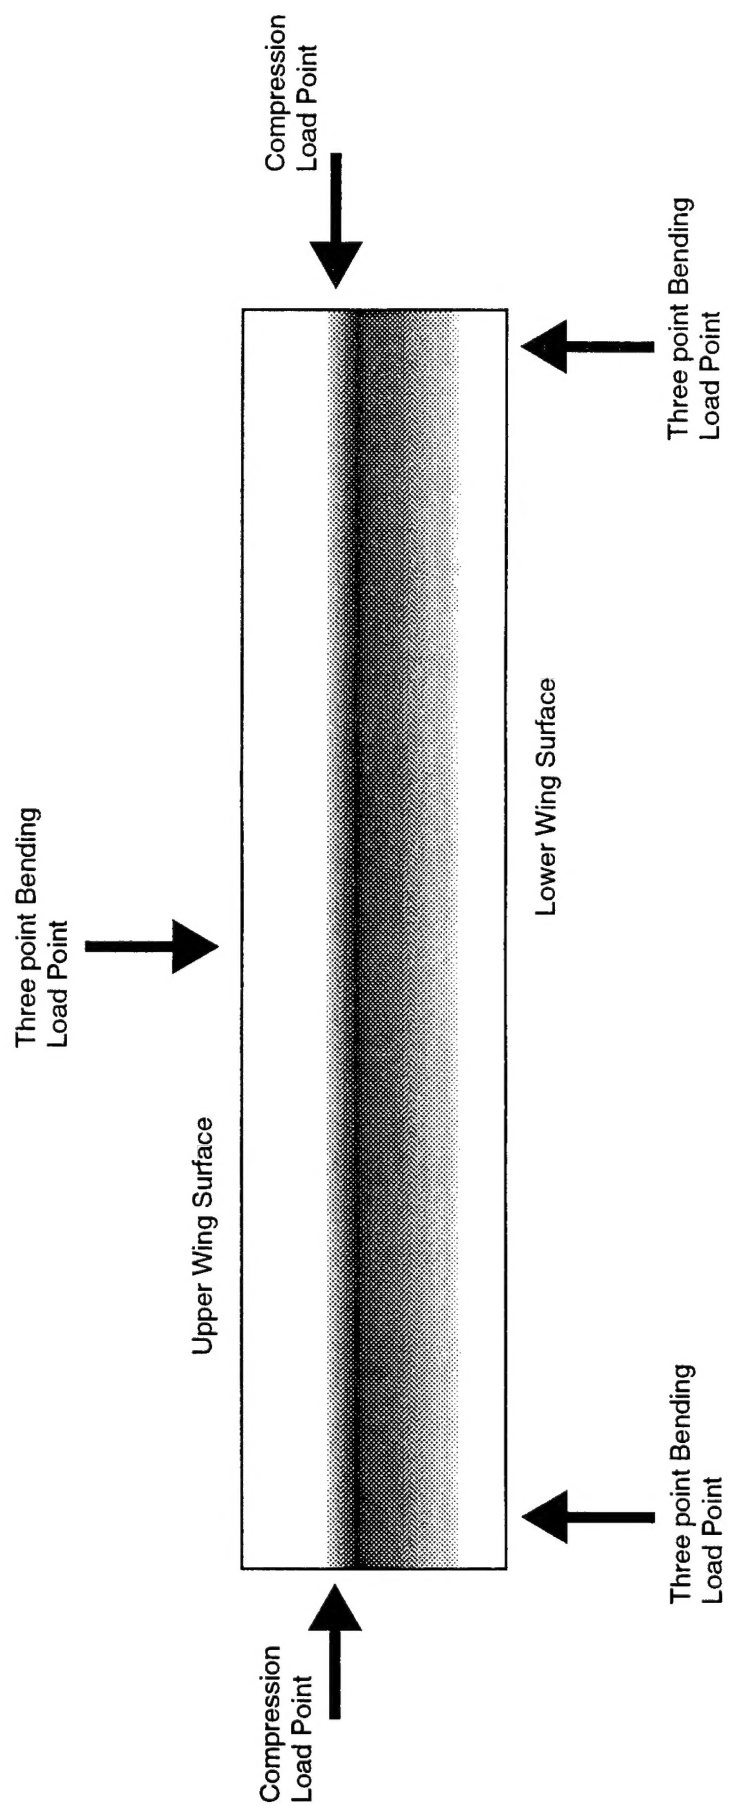
Figure 13. Diagram of the two Proposed Loading Configurations Which could Cause the Upper surface to Buckle
